# METAL THEFT

Angus Brown

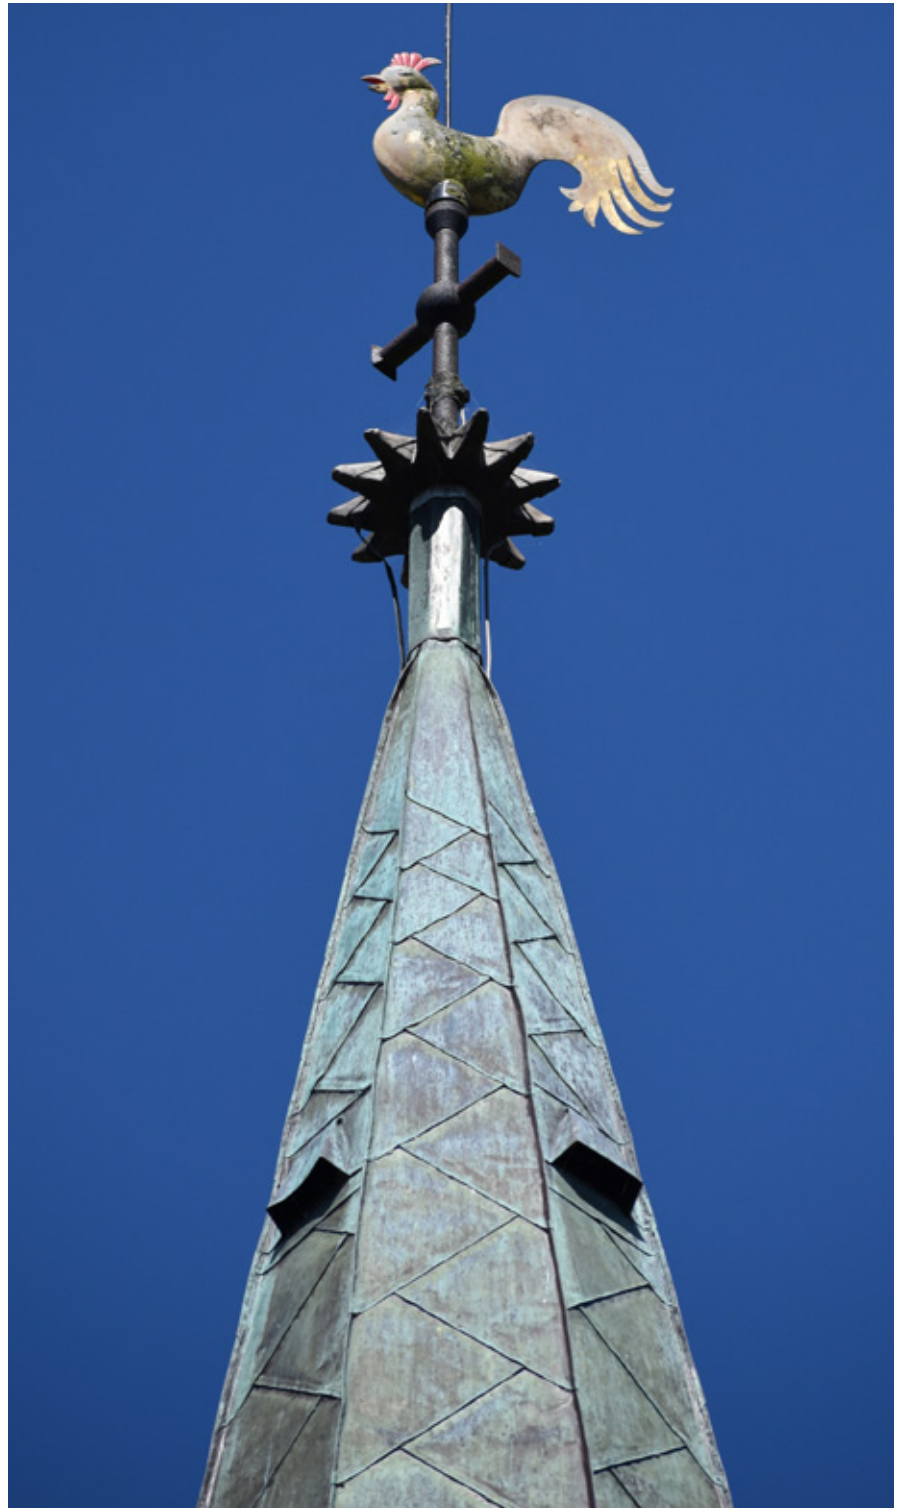
*Although lead is the most common metal roofing material used historically, copper was widely used for decorative effect, as here on the steeple of St Mary's, West Harptree. (Photo: Jonathan Taylor)*

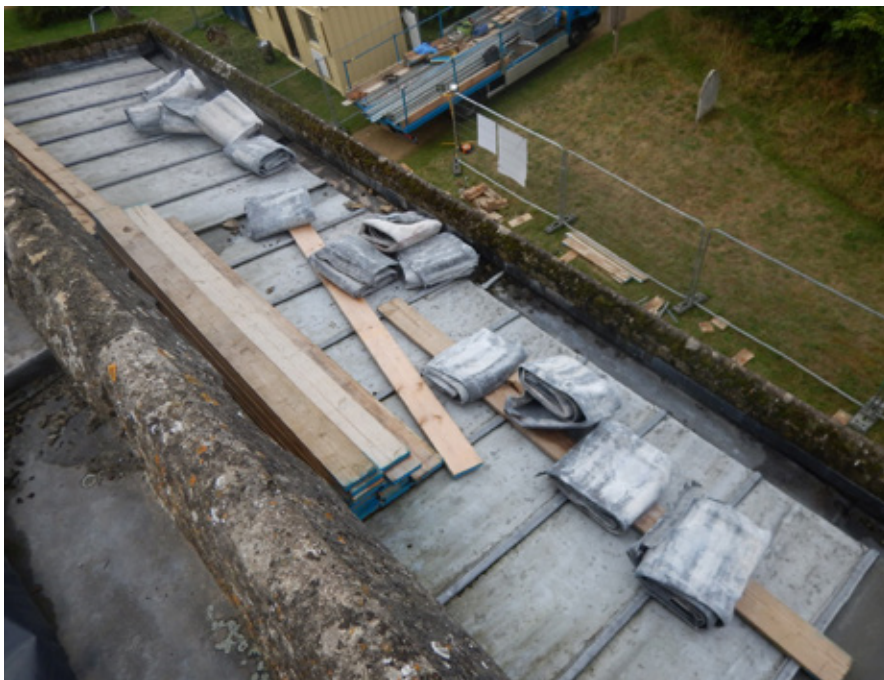
*St Mary the Virgin, Kirtlington, Oxfordshire, with neatly rolled up sheets of lead left by in a hurry by the burglars (Photo: Angus Brown)*

At St Mary's, Kirtlington for example (see illustration), the thieves did not get away with much of the lead before a curious neighbour decided to call the police. Nevertheless, this clearly well-schooled gang was able to cause significant damage that will cost tens of thousands to put right, even if they didn't ultimately manage to take their spoils with them.

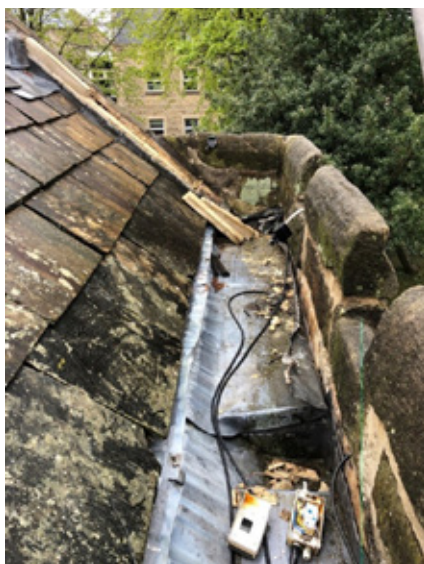
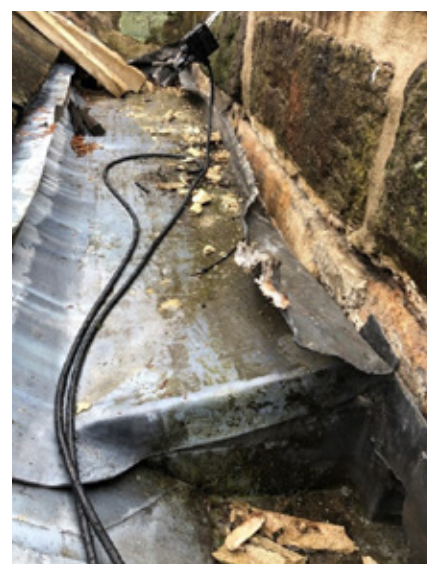
*St Bartholomew's, Colne; (left) the uplifting of the lead flashing and external lighting cables which had been ripped up, and (right) a close-up of the damage caused to flashing and stonework (Photo: Angus Brown)*

Lead thieves struck the church on the morning of 6th May 2022. When the alarm receiving centre (ARC) received alerts indicating that there was movement on the roof of the building, it immediately alerted the previously agreed contact points at the church to warn them of the potential attack. In the meantime, a neighbour who had heard the sounding of the alarm called the police, resulting in the thieves being arrested on site with tools in hand. Although the intruders had lifted some of the lead flashing in areas, they were unsuccessful in actually removing any lead from the church building.
